www.serviceprocess.net
Service Process Equipment, Inc.
PO Box 850908
Mobile AL 36685-0908
251.342.1313 Fax 251.342.1377
Email msellers@serviceprocess.net

Note: We repair BOTH Block and Shell & Tube HX. This is a sample report we give on every repair.

May 22, 2013

Concerning your repaired unit. Mersen Gonzales has completed repairs as quoted.

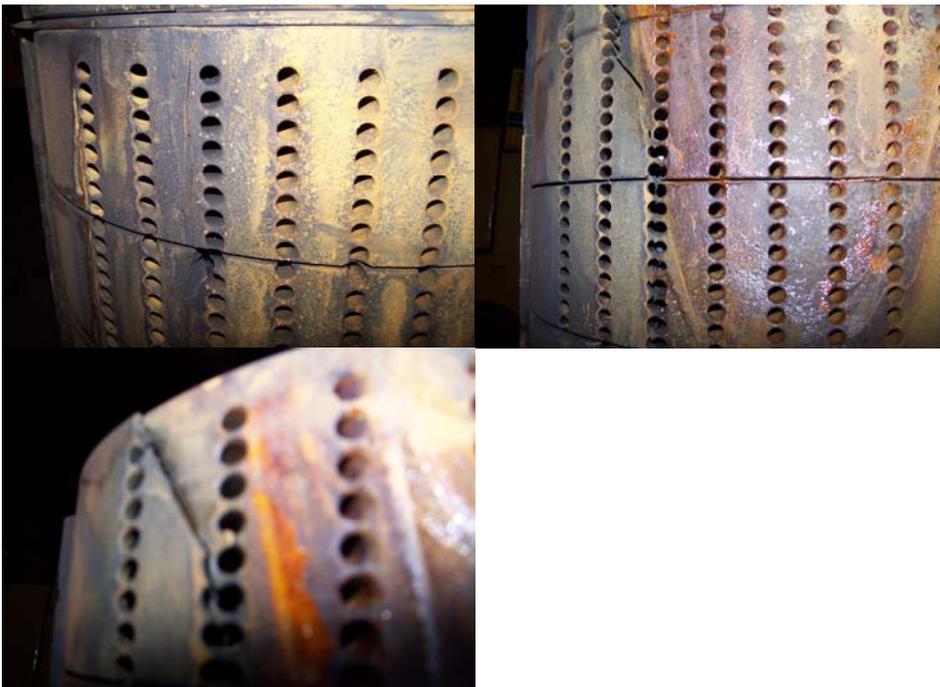
Picture 1 – 3 – Cracked block

- There was 1 cracked block in exchanger upon shell removal.
- A Phenolic block was put in its place.
- All graphite was cleaned and impregnated.
- A new shell was made.
- Unit was assembled using all “new” gaskets, packing and metric hardware.
- Exchanger was steamed and tested ok at 80 psi.
- Unit was palletized and shipped with 20 psi.

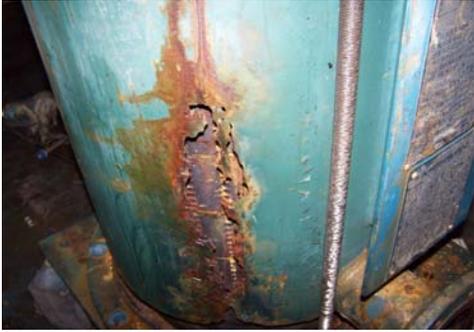
Picture 4 – Shell erosion.

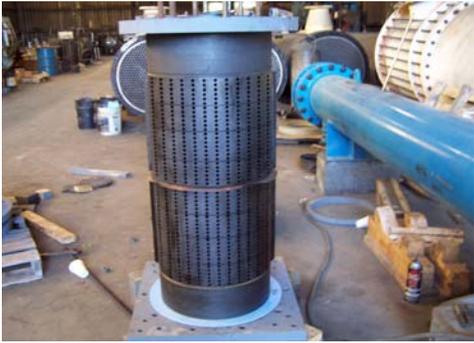
Picture 5 – 2 blocks to test.

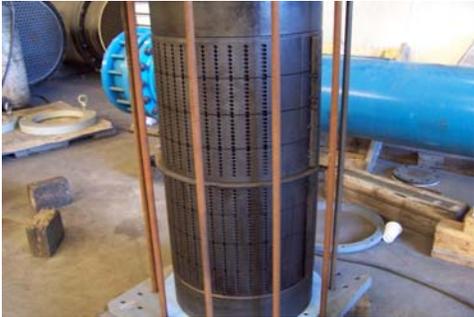
Picture 6– Blocks on test

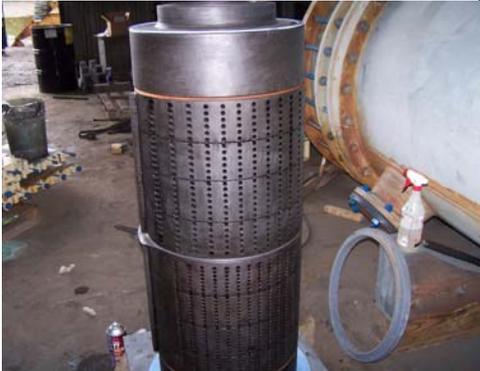
Picture 7 – Phenolic block on top.

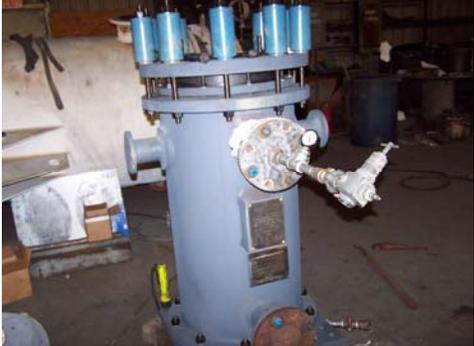
Picture 8 – Completed exchanger on test.

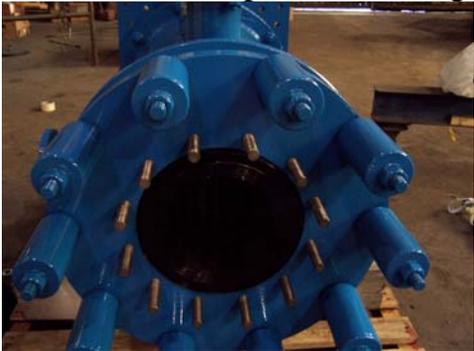
Picture 9 – Completed exchanger to ship.

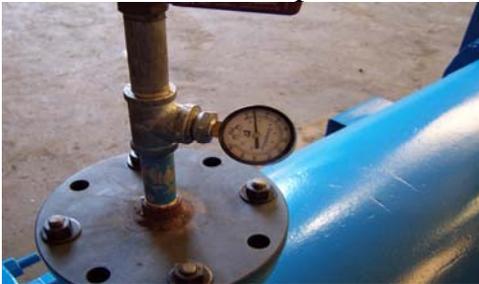
Picture 10 – We ship units under pressure to make sure they are ready to go !
